**Missouri Breaks Fire Complex (F176,F205,F207,F216)
BURNED AREA EMERGENCY STABILIZATION AND REHABILITATION (ESR) PLAN**

AGENCY/UNIT: Charles M. Russell National Wildlife Refuge

LOCATION: Jordan, Garfield County, Montana

DATE: September 4, 2003

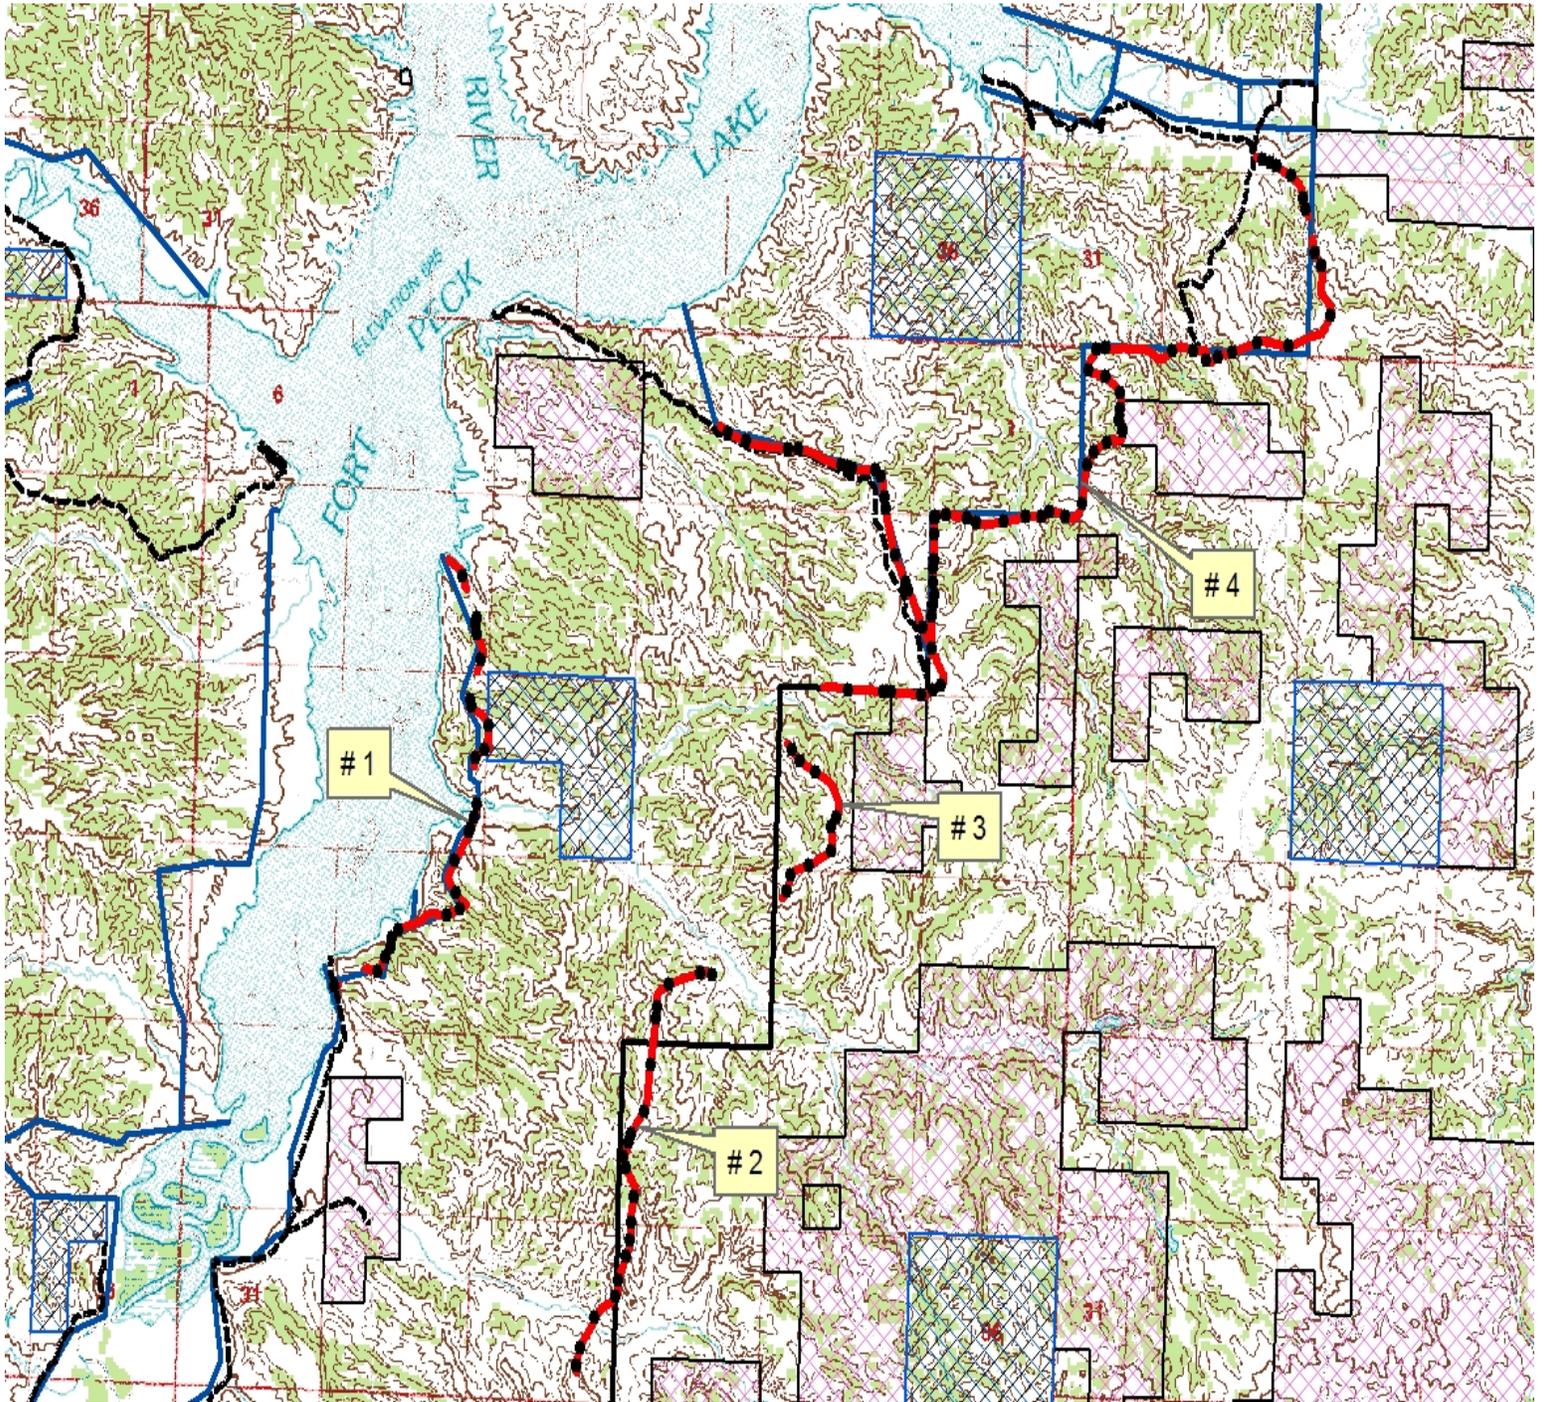
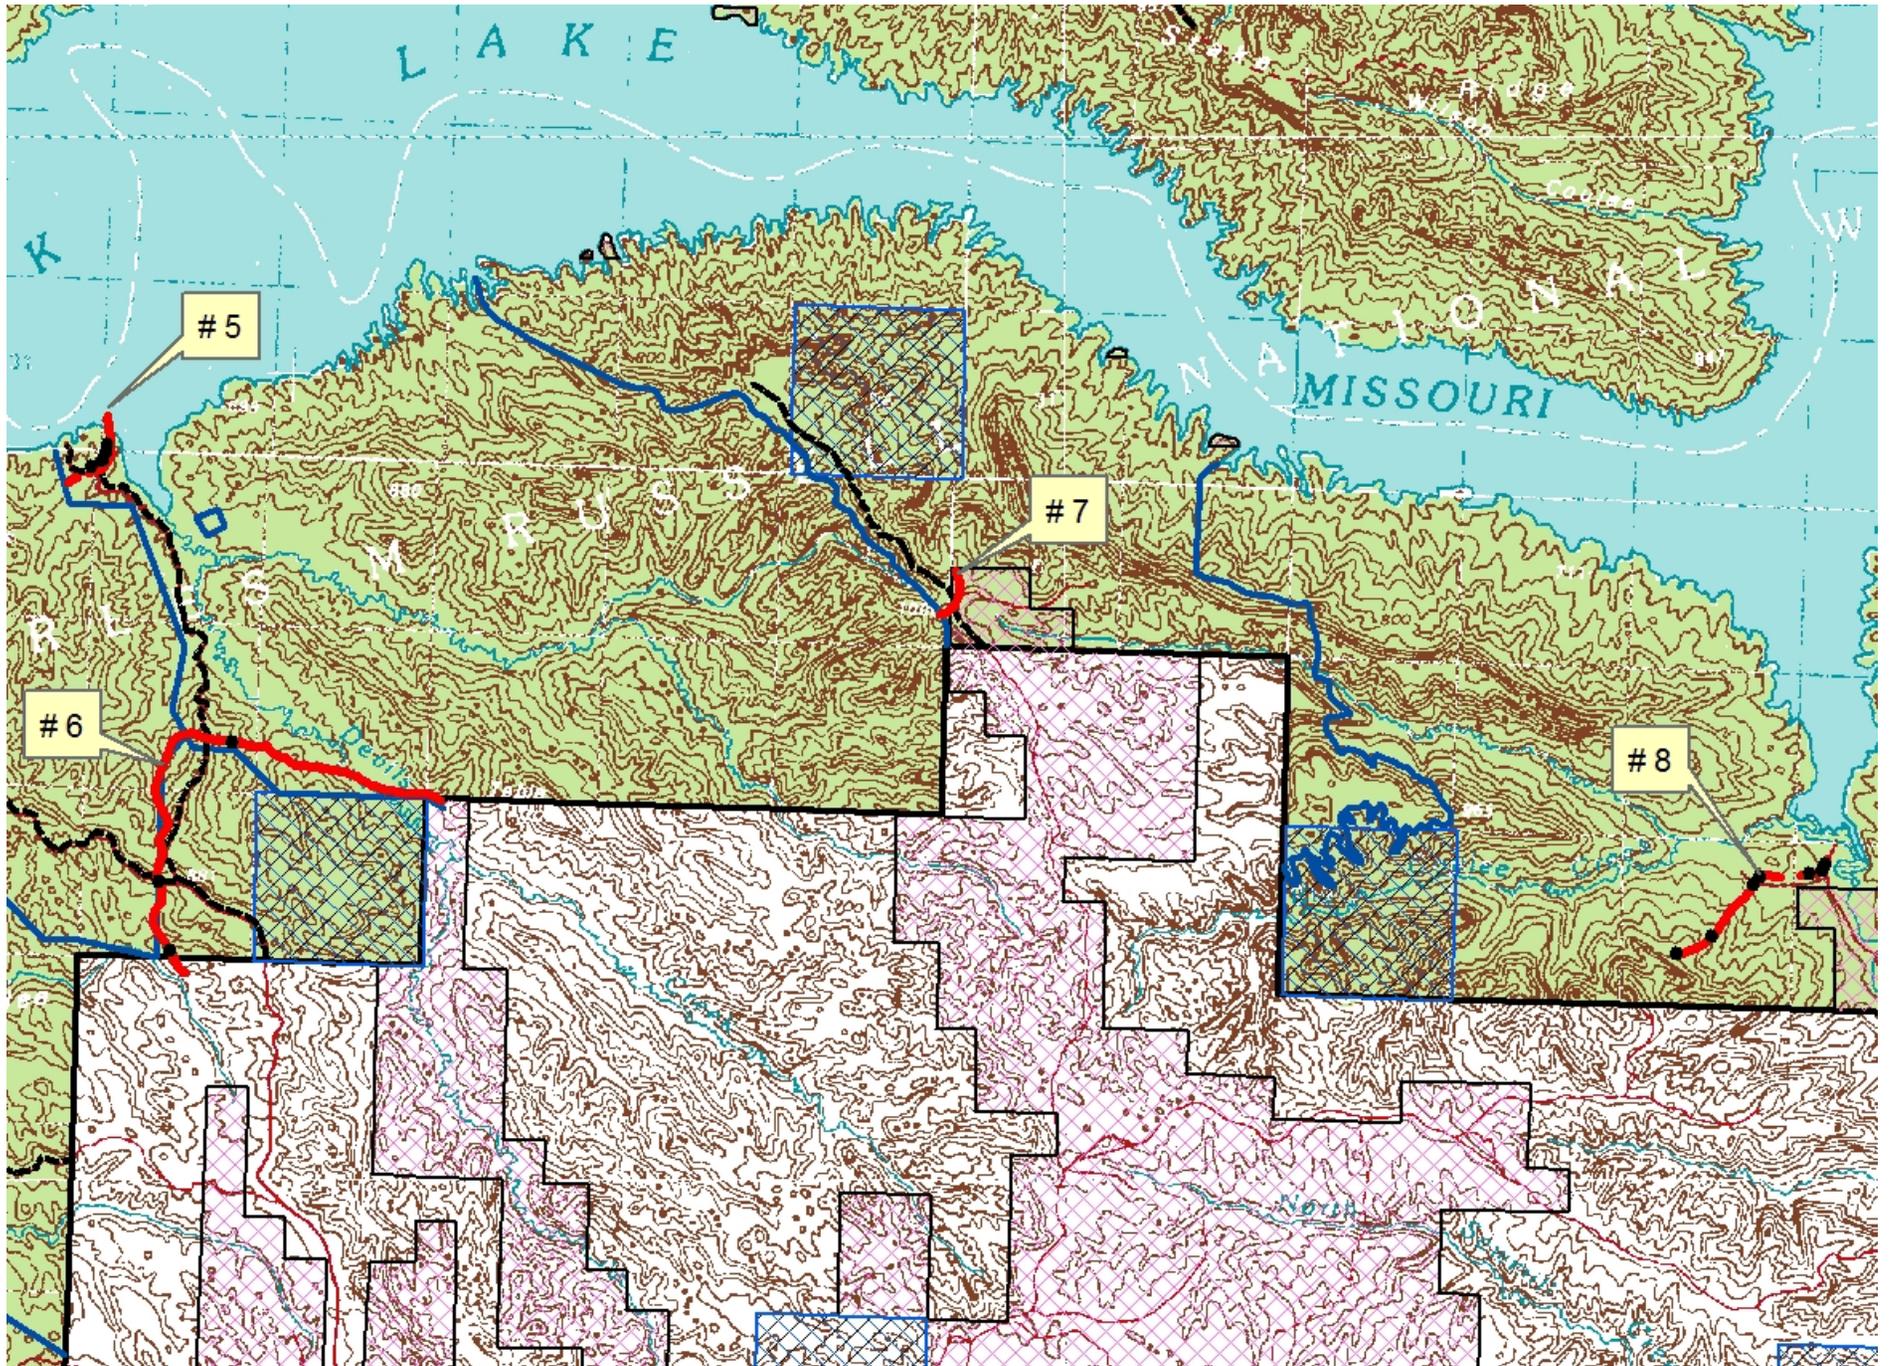
APPENDIX II MAPS OF FENCES

On August 1, 2003, Tim Miller (Jordan) and Randy Matchett (Lewistown) inventoried fire-damaged fences in the July, 2003 Missouri River Breaks Complex of fires in northwestern Garfield County, MT via helicopter and GPS-mapping. Table 1 summarizes structure damage and should be considered a minimum inventory as only remaining wood structures could be tallied. Single wood posts were not tallied. Wood structures on fences within burned areas, but with no visible damage were not tallied, but may still need replacement upon closer inspection. No assessment of wire or steel post damage could be made, but the accompanying maps show sections of fence within burned areas.

Fence #1: Mussellshell Exclosure. Burning was scattered and relatively cool, but many structures were damaged. The area around the building near the mouth of Sherman Coulee was burned, but fence damage was not assessed.

Fence #2: Sherman-Germaine Coulee Fence. Fire was more intense with substantial damage in some sections.

Fence #3: North Germaine Coulee Fence. Variable fire intensity with substantial damage in some sections.

Fence #4: Anderson Point - Squaw Creek Fence. Variable fire intensity with substantial damage in some sections. Portions of this fence were in extremely steep terrain and other routes may need to be considered.

Fence #5: Devils Creek Recreation Area. Light fire intensity, but at least 4 structures need replacement.

Fence #6: Southwest Devils Creek. Much of this fence looked to be old, mostly cedar posts and only sections could be found. The entire section needs replacing and re-routing should be considered. Very few wood structures could be seen.

Fence #7: Herman Ridge. Much of this fence appears as natural breaks and the section on the map was the only section located. Again, it was old, all cedar posts and could not be traced more than mapped. The entire section needs re-evaluating/replacing. There is no burned area to the west-northwest from the ridge top at the end of the road to the lake.

Fence #8: 7-Blackfoot. Fire intensity was much less than in other areas, but several structures were damaged. In re-building, should consider a legal survey and re-routing to exclude private land, but according to approximate aerial map, fence already excludes private ... check later.

Rebuild damaged fences and rest units from livestock grazing from 1-3 years.
